Manhole Inspection Summary

Manhole # S23A__009MH

Insp Date: **7/30/07 9:51 AM**

Location Address: **1303 HARLEM AVE**

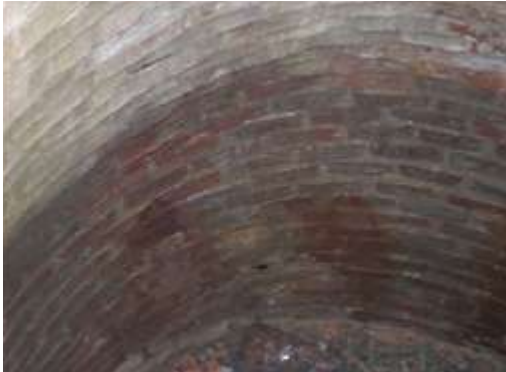
Defect 4

Barrel Material: **Brick** ☐ Parged
Shape: **Circular** Diameter: **46** (in.) Length: (in.)
Condition: ☒ Sound ☐ Cracked ☐ Root Intrusion ☐ Loose Brick ☐ Deteriorated
Infiltration: ☐ None ☐ Joint ☐ Cracks ☐ Mortar ☐ Roots ☒ **Wall**

INFILTRATION OF BARREL

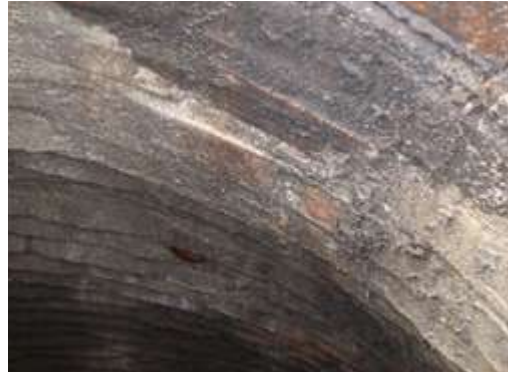
Defect 3

Corbel Material: **Brick** ☐ Parged Type: **Concentric/Eccentric**
Condition: ☒ Sound ☐ Cracked ☐ Root Intrusion ☐ Loose Brick ☐ Deteriorated
Infiltration: ☐ None ☐ Joint ☐ Cracks ☐ Mortar ☐ Roots ☒ **Wall**

INFILTRATION OF CORBEL

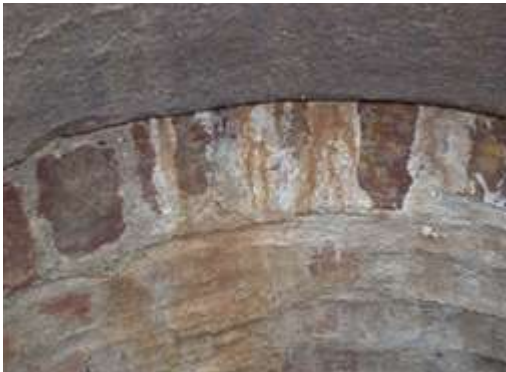
Defect 2

Chimney / Frame Adjustment ☒ Exists Material: **Brick** ☐ Parged Height: **6** (in.)
Condition: ☐ Sound ☒ **Cracked** ☐ Root Intrusion ☐ Loose Brick ☐ Deteriorated
Infiltration: ☒ None ☐ Joint ☐ Cracks ☐ Mortar ☐ Roots ☐ Wall

CRACKED CHIMNEY

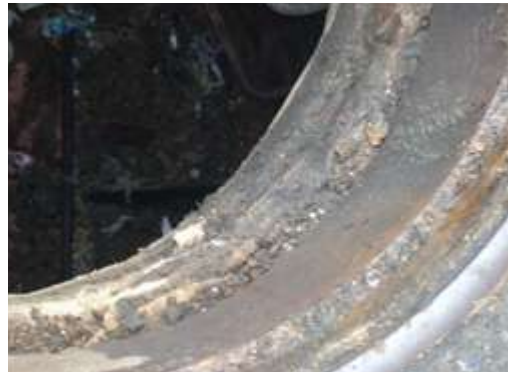
Defect 1

Frame Offset: **1** (in.) Condition: ☒ Sound ☐ Cracked ☐ Leaks

FRAME OFFSET

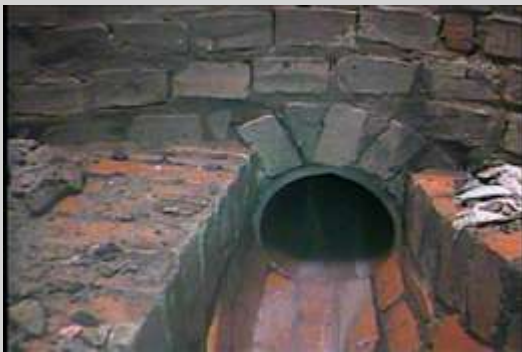
12 O'Clock Outflow

8 in. Circular Gravity Sewer
Pipe Out @ 12 O'Clock

Pipe Height: **8.4** (in.) Rod and Bar (Angled)
Pipe Material: **Clay** ☐ Pipe Lined
Invert Depth: **9.11** (ft.) Flow Characteristics: **Fast**
Deposits: ☒ None ☐ Mud ☐ Sludge ☐ Debris ☐ Grease
Silt Depth: (in.) Deposits Extent:
Infiltration: **None** Pipe Seal Cond: **Sound**

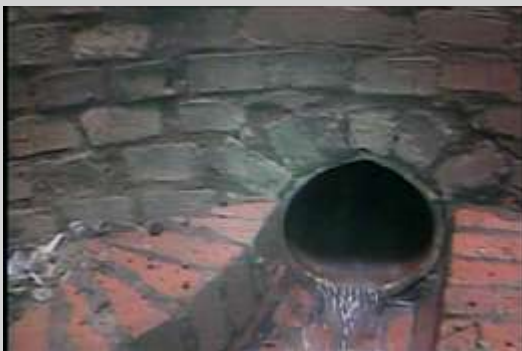
3 O'Clock Inflow

8 in. Circular Gravity Sewer
Pipe In @ 3 O'Clock

Pipe Height: **8.4** (in.) Rod and Bar (Angled)
Pipe Material: **Clay** ☐ Pipe Lined
Invert Depth: **8.64** (ft.) Flow Characteristics: **Fast**
Deposits: ☒ None ☐ Mud ☐ Sludge ☐ Debris ☐ Grease
Silt Depth: (in.) Deposits Extent:
Infiltration: **None** Pipe Seal Cond: **Sound**
